PRELIMINARY REPORT

ATF-5

ATF-5 REPORT

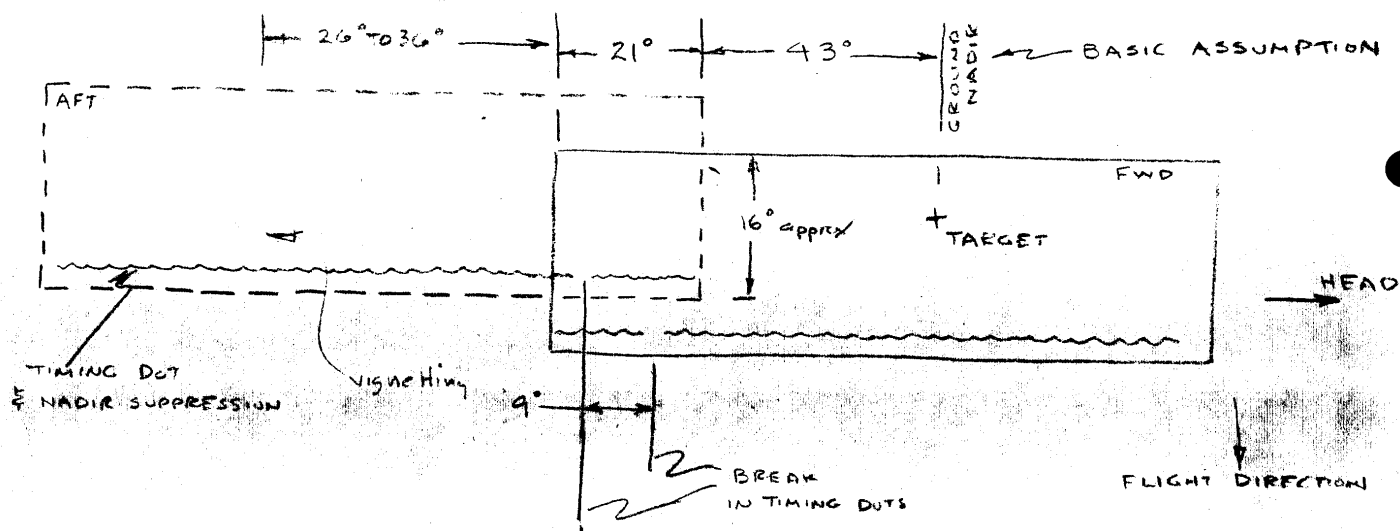
ATF-5
SCANNER PHASING
RUN 1

Scanners not phased properly. Forward scanner leading its correct position by 45° and aft scanner leading its correct position by 55° . This means that aft scanner was leading the forward scanner by 10° instead of $42\frac{1}{2}^{\circ}$. On ATF-4 the forward scanner was phased properly (to about $\pm 3^{\circ}$) and the aft was misphased (leading) 40° --the same condition as LTF-17.

ANGLES IN TERMS OF β AT 3.25" / INCH OF FILM
ANGLES MEASURED $\pm 5^\circ$

FWD TO FWD OVER-LOOK = 2 INCHES OF FRAME $\approx 3^\circ$ OF α

- 5.1 Rephase scanners and check IMC, capping shutter phasing.
- 5.2 Implement correction of slit relay pulse (elements relay).
- 5.3 Check V/h sensor grid frequency, focus, wiring from interface package to system and test signal wiring.
- 5.4 Locate break in LVSYN test signal lead and correct.
- 5.5 Do not short cut ground check-out with Brush recorder.
- 5.6 Replace Natel Master Oscillator (spare available December 14th).
- 5.7 Institute search for cause of static (or pressure) marks.
- 5.8 Recommend fly same test again, after corrections.
